TCP/IND/6712
Field Document No. 4

TRAINING IN SEA SAFETY DEVELOPMENT

Based on the Work of
Oyvind Gulbrandsen
FAO Consultant Naval Architect
(2 June – 2 July 1998)

FOOD AND AGRICULTURE ORGANIZATION OF THE UNITED NATIONS
Bangkok, August 1998

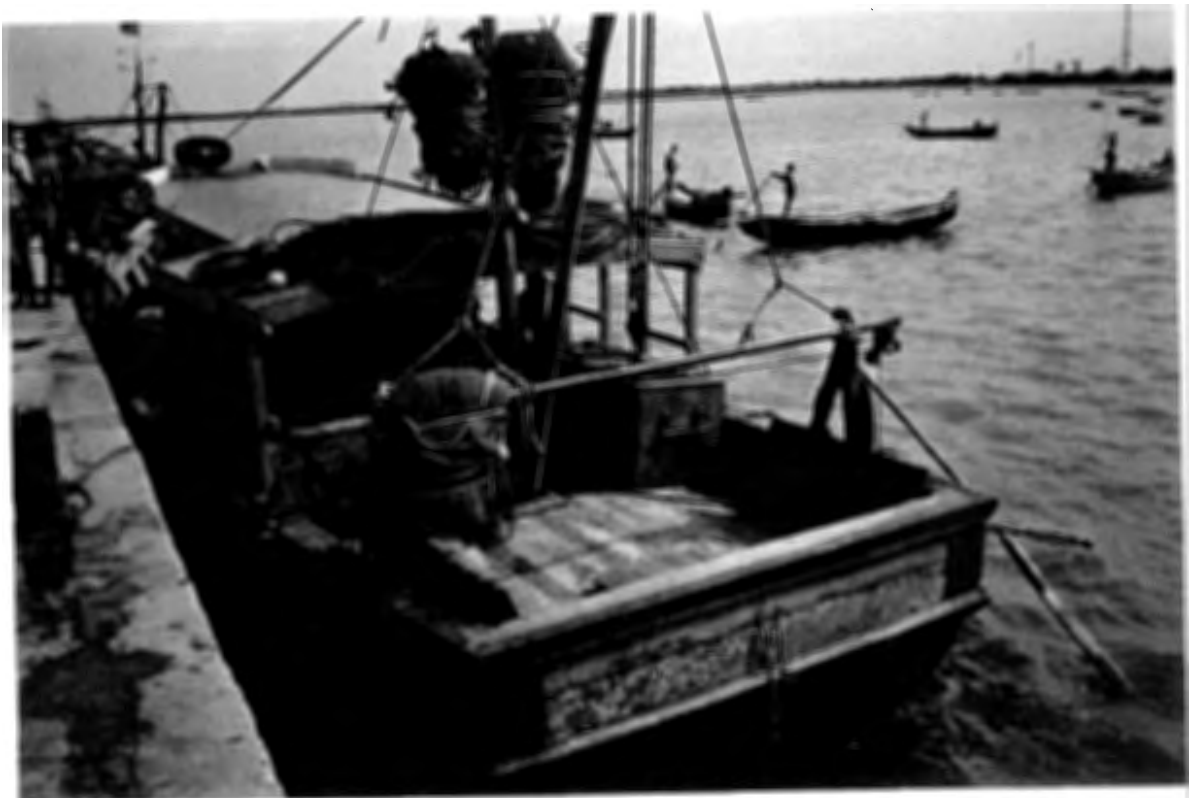
Although the Stability Certificates of new "Sona" boats indicate a high initial stability it is not stated in which condition the vessel is tested, how much fuel and freshwater there is in the tanks and whether the ice boxes on deck are in position. When the iceboxes on deck are full they have a significant effect on the stability, especially on the smaller "Royya" type which does not carry iceboxes under deck (Fig. 9). The minimum GM = 0.35 m is an international criteria for fishing boats above 24 m in length that undergo a complete stability investigation including calculation of righting levers at various angles of heel. This criteria is certainly too low for the boats of the size we are dealing with since a complete stability check is not made. The criteria for minimum GM given in Ref. 3 under 4.2.3 should be used. A complete stability calculation should be made for a typical "Sona " trawler to judge the effect of water on deck following the recommendation in Attachment 3 of Ref. 4 . The high depth moulded in relation to the waterline beam on this type of boat, makes it vulnerable to weights on deck.

Fig. 6. Trawler with iceboxes on deck

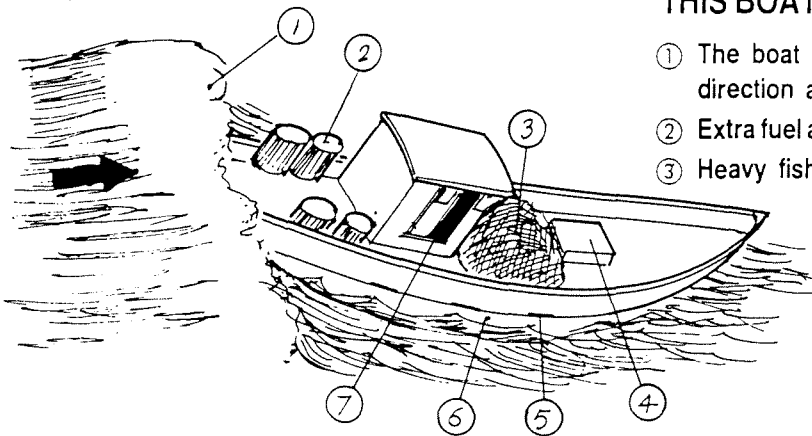
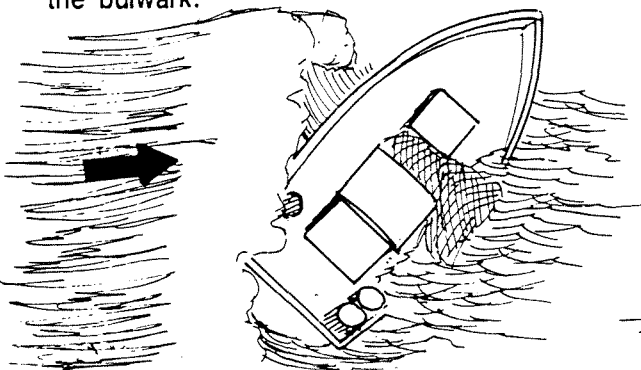
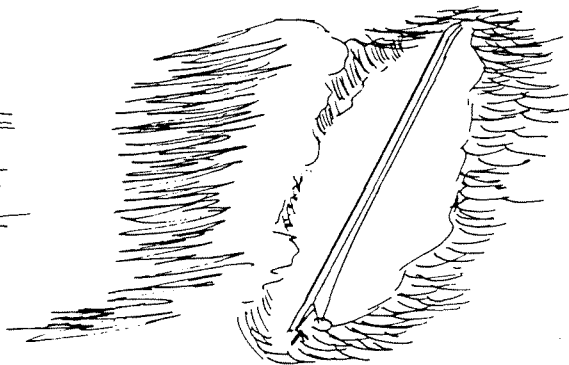
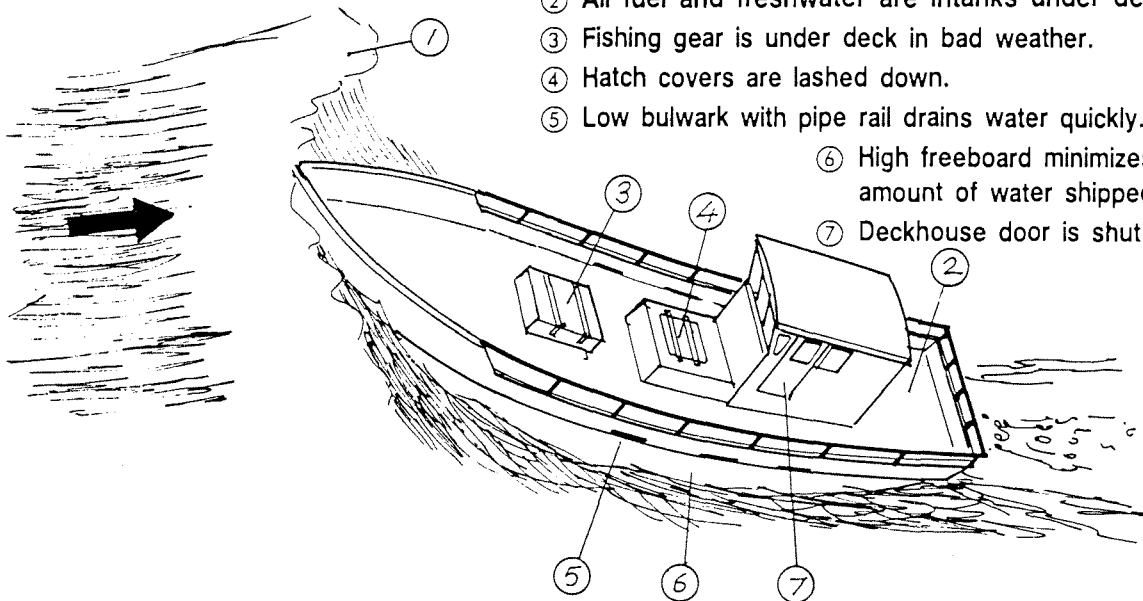
Fig 7. Causes for capsizing

- When the trawlers were hit by the cyclone late at night on 6 November 1996, the first thought of the skipper was usually to head back to Kakinada. When the wind and wave direction made progress very slow, they decided to turn around and go with the wind and the waves in order to seek the nearest port in that direction. A breaking wave from astern or the side filled the deck, washed away unsecured hatch covers, filled up the engine room and stopped the engine. The boat could not be manoeuvred and capsized from a side wave (Fig. 7).

- Capsize without the engine stopping was also reported. The boat went over very quickly due to the weight of water trapped between the bulwark and iceboxes on deck.

- ① The boat is going full speed in the same direction as the waves
- ② Extra fuel and fresh water are in drums on deck.
- ③ Heavy fishing gear is on deck.
- ④ Hatch covers are not lashed.
- ⑤ Freeing ports are small.
- ⑥ Freeboard is low.
- ⑦ Deckhouse door is open.

The boat is likely to be thrown broadside to the waves and the fishing gear and drums are likely to slide over the bulwark.

The boat is then likely to capsize with the next large wave.

- ① The boat is going slowly against the waves.
- ② All fuel and freshwater are in tanks under deck.
- ③ Fishing gear is under deck in bad weather.
- ④ Hatch covers are lashed down.
- ⑤ Low bulwark with pipe rail drains water quickly.
- ⑥ High freeboard minimizes the amount of water shipped in.
- ⑦ Deckhouse door is shut.

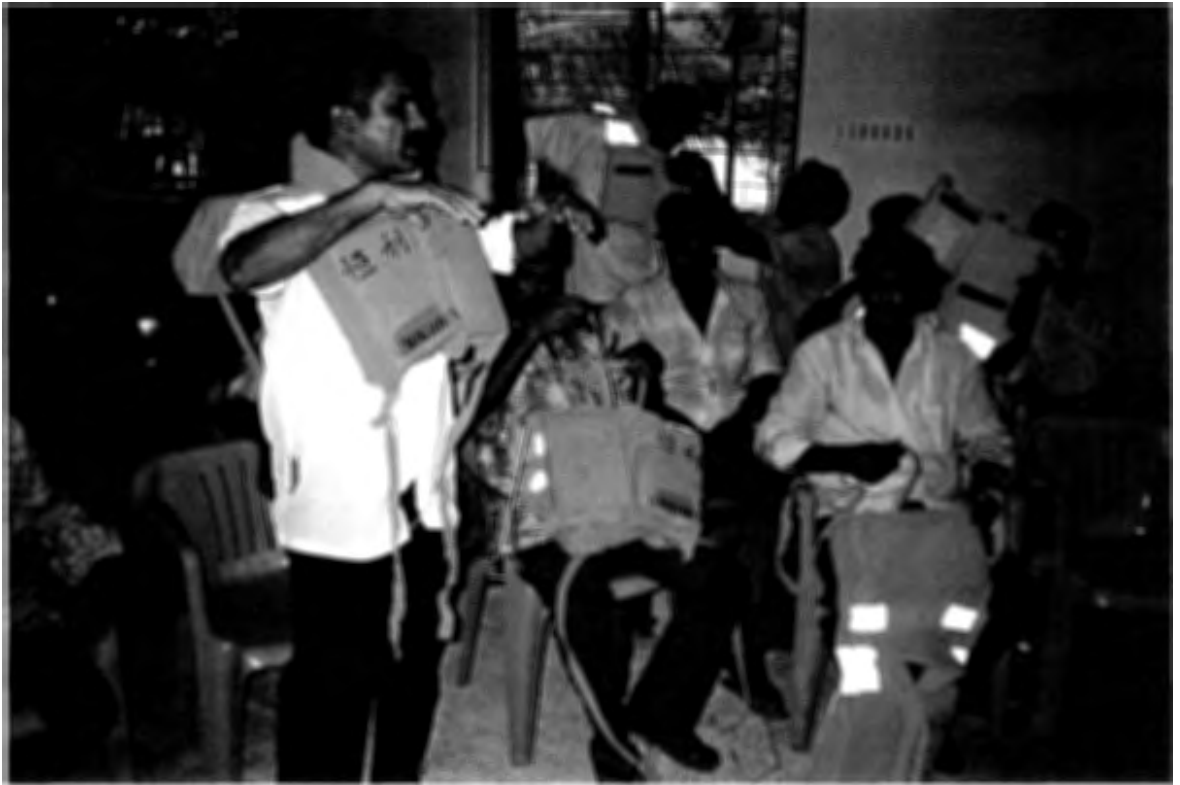
Fig.8. Training course for staff from Fisheries Training Institute and Fisheries Department. Participants were asked to tie on a lifejacket. None were able to do it without further training.

3. Only lifejackets made with rot resistant synthetic covers and foam buoyancy material should be accepted. The crew must be drilled in how to tie on the life jacket.

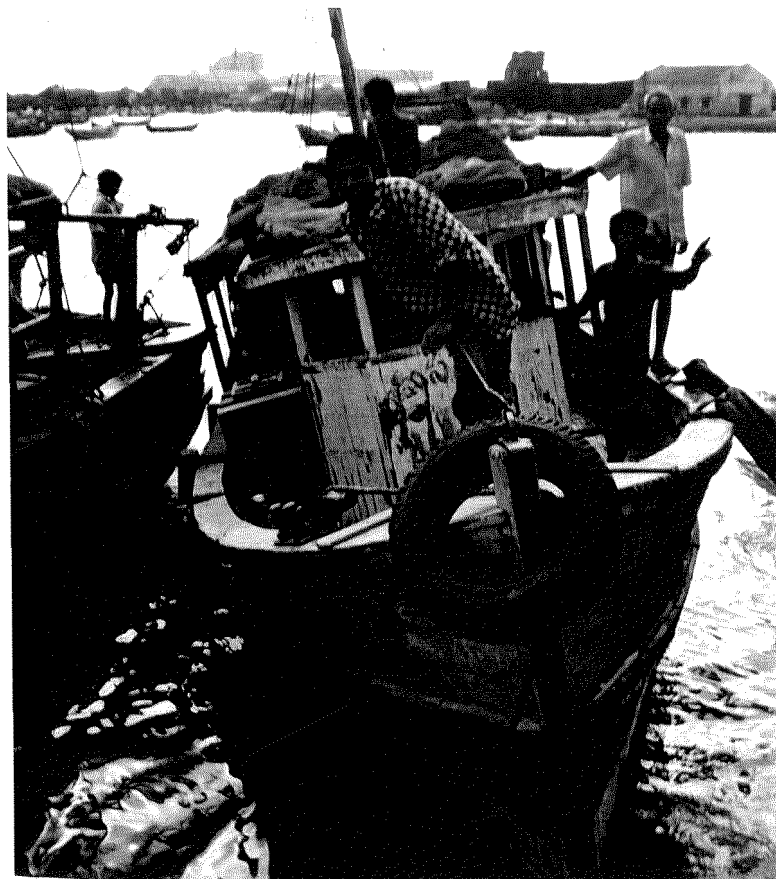
Fig.9. 10 m "Royya" type of trawler with icebox on deck. Angle of heel when arriving in port indicates low stability.

5. A complete stability calculation should be made for a typical "Sona" boat, taking into account all loading conditions as well as ice boxes on deck and water on deck, to check whether the high Depth/Beam ratio of these boats represents a danger.

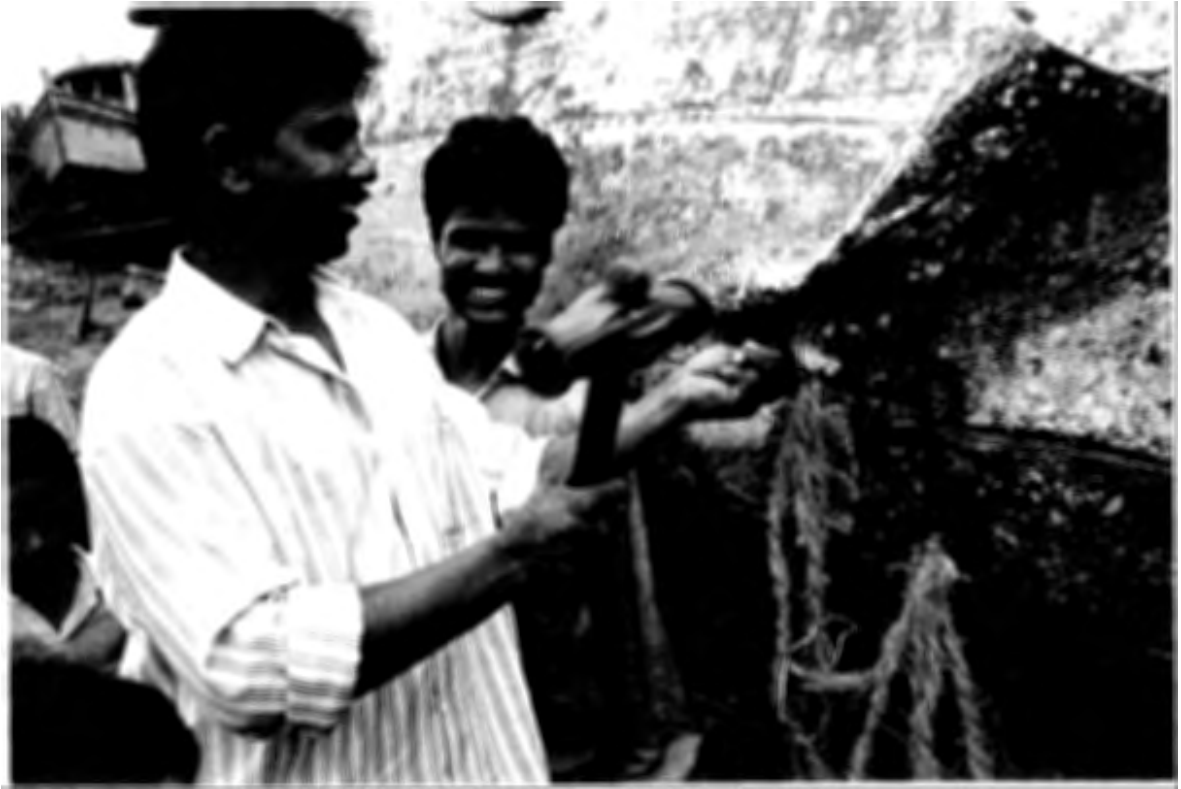
- The scantlings are below what is normally prescribed in scantling rules. The planking thickness is 25-26 mm while minimum plank thickness for this size of

boat (CUNO = 80) would normally be 30 mm. The frame distance, centre to centre, is 400 mm while normal distance should be 320 mm. The larger framespacing, together with the thinner planking, leads to a considerable weaker construction. **It seems that the plank thickness and the frame spacing have not been modified from the earlier 10 m "Royya" type of boat with a CUNO = 36 m³ even though the trawlers now are double the size with a CUNO = 80 m³.**

- Big gaps between the planks occur after a few years service and this requires massive caulking to stop the leak (Fig. 10). Although it is not possible to directly link the weak construction of the trawlers to the sinkings during the cyclone, it is clear that the present scantlings present a safety hazard.

Fig. 10. A leak in a five year old trawler is stopped by massive caulking. The large gaps between the planks are caused by weak construction

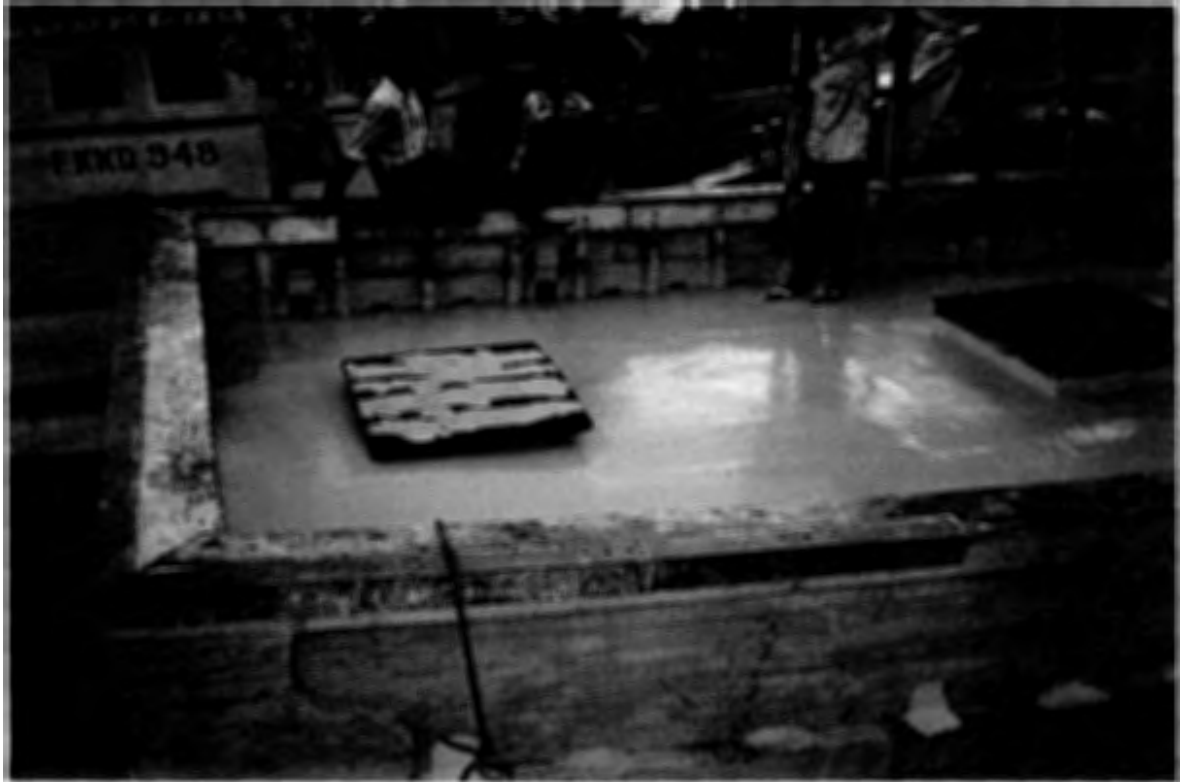
- In many cases the hatch covers to the fish hold and to the rudder compartment cannot be fastened down in such a way that they will not be washed away by a wave breaking on the deck (Fig. 11). The height of the hatch coaming, which is recommended (Ref. 5) to be minimum 300 mm, is in most cases half this height or less. This also applies to the coaming height for doors into the wheelhouse where water will enter easily into the engine room.

- The scuppers in the bulwark (Fig 11) should be sufficiently large to prevent large quantities of water being trapped on deck. They have a combined area of about one third of what is recommended (Ref. 5).

Fig. 11. This is a typical trawler with no means to clamp down the hatchcovers. Drainage openings (scuppers) in the bulwark are about one third the size recommended by international guidelines

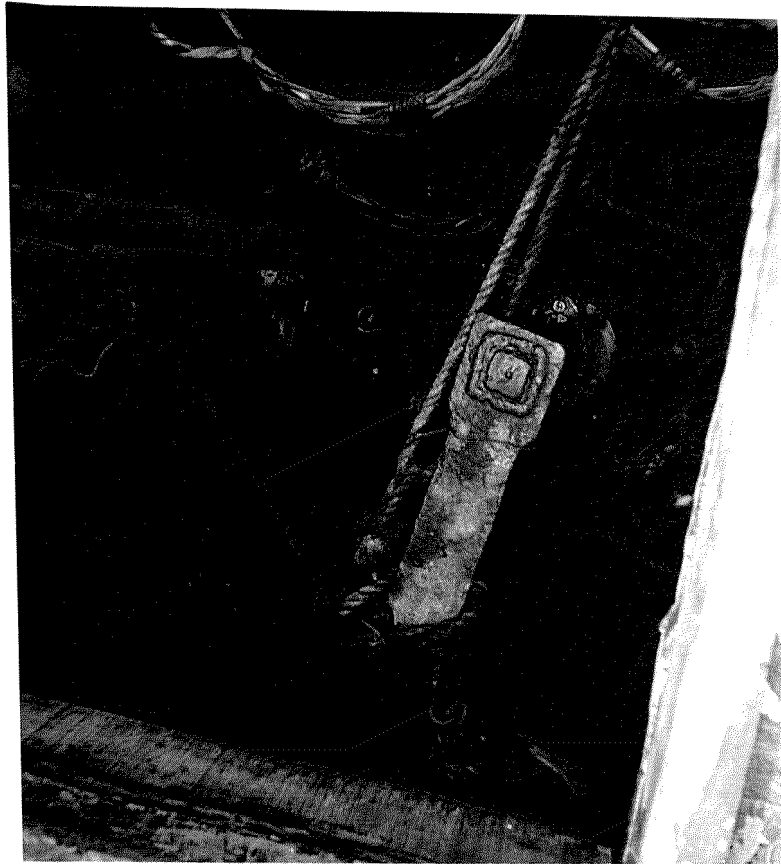
Fig.12. The rudder tiller is connected to the steering wheel by rope. No proper rudder stops. This is not acceptable on a 12 m trawler. Breaking of this rope was the cause for the loss of at least one trawler during the cyclone.
