## **PART IV**

### **MANUFACTURING DEFECTS AND REPAIRS**

## 12 - REPAIRS

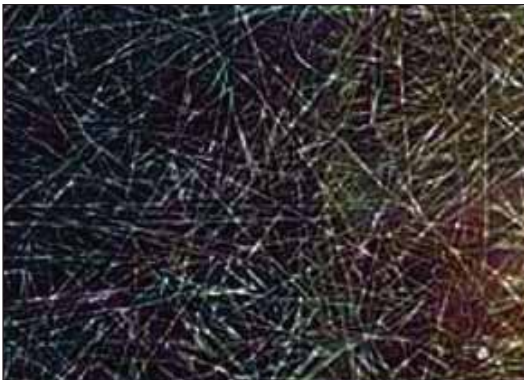
**Figure 134**

Fibre pattern is a result of:

- gelcoat too thin.
- high exotherm because of bulk curing.

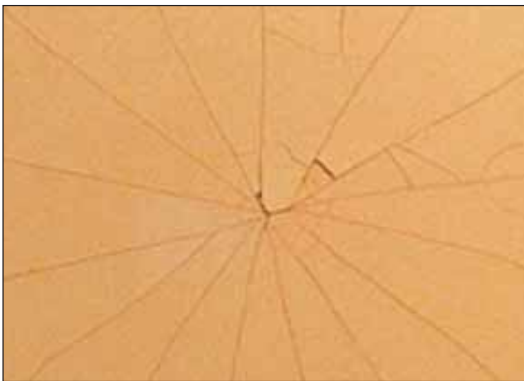
**Figure 135**

Star crazing is caused by:

- gelcoat too thick.
- reverse impact.
- crack pattern transferred from mould.

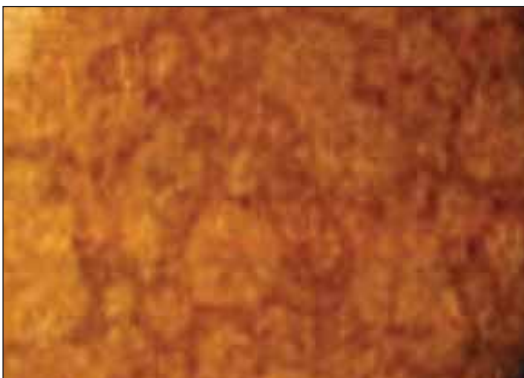
**Figure 136**

Blisters are caused by:

- moisture contamination.
- rapid cure of gelcoat.

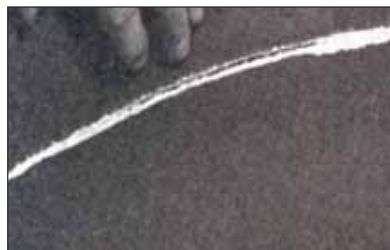
**Figure 138**  
Severe grazing caused by scratching.

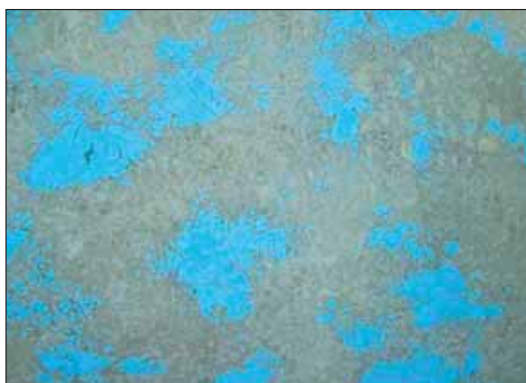
**Figure 141**

In this figure, old laminate showing typical results of hydrolysis can be seen. The polyester becomes depolymerized and is washed out of the laminate.

The results are visible as dark spots on the surface and white pockets deeper in the laminate.

If the gelcoat is intact, osmosis blisters might occur.

Old laminate is weaker and less stiff than new laminate, even if damage is not visible.

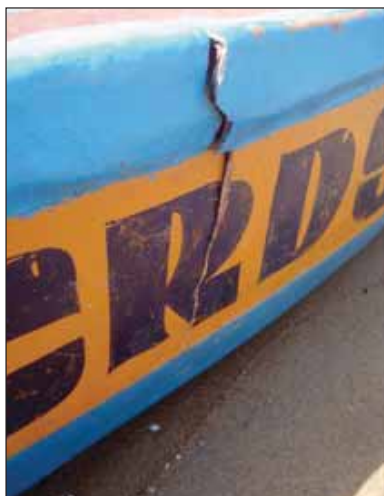
**Figure 142**

Many boats have laminates that are just too thin.

On this boat, the laminate was 4 mm but the layers separated easily because of the excessive use of pigment and too much polyester with respect to glass.

The boat would have survived had the gunwale been made tougher.

The polyester to fibreglass volume percentage should be approximately 67 percent polyester to 33 percent fibreglass.

The coaming had layers of putty in between the laminate layers.

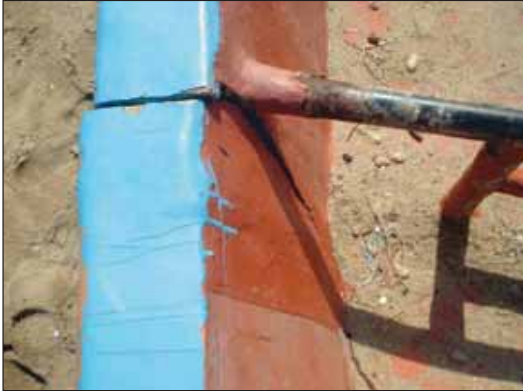
**Figure 143**

In addition to the iron posts working their way out, the area where the posts are connected to the hull is in itself a “stress riser” and many boats have failures here.

It might be easy to think that the boat breaks at this point because of the pull in the steel bars, but the truth is that it breaks because the rest of the boat is soft and this is a stiff and weak point.

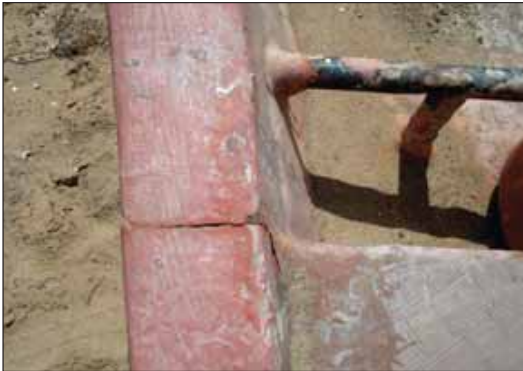
**Figure 144**

Since the structure of the boat is somewhat “soft”, the bending of the laminate will concentrate in “hard spots” where cracks and delaminations will develop.

All corners should be well rounded and areas with stress risers should have additional layers of FRP to absorb and distribute the stress and strain.

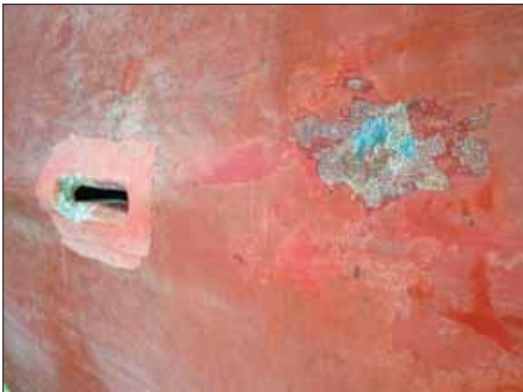
**Figure 145**

At the bottom of the boat, there are wear-and-tear failures caused by abrasion, as well as cracks and delaminations resulting from thin laminates and local stress risers, such as the leeboard holes and poor detailing in internal structural supports.

Additional strips of prefabricated FRP laminates could be glued on for additional stiffness and abrasion resistance.

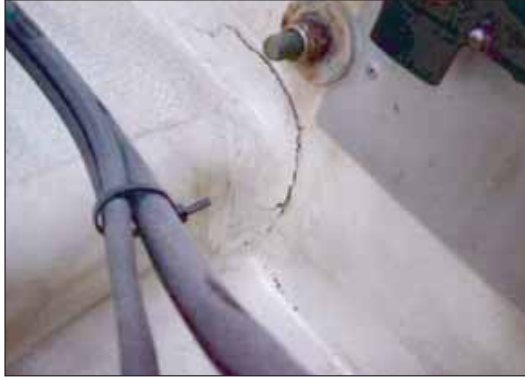
**Figure 146**

This figure shows a typical fatigue fracture inside the transom on a boat powered by an outboard engine.

In this case, an attempt has been made to repair the crack, but putty and gelcoat cannot mend structural damage.

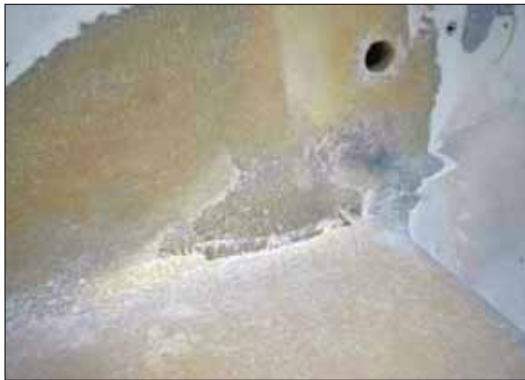
**Figure 147**

Prior to grinding, all surface contamination such as oil and silicone should be washed off and removed with an appropriate solvent. For grinding, 40-grit sandpaper is a good choice.

In the example shown here, grinding has uncovered deep delaminations. To ensure a lasting repair, the full extent of the delaminated fibreglass must first be removed, no matter how far or deep it extends

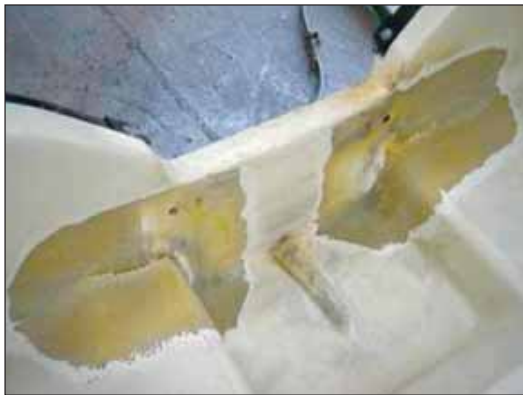
**Figure 149**

When grinding has been completed, the area to be laminated will probably be much larger than suggested by the initial visual inspection.

For example, in this boat, tiny cracks in the gelcoat were visible on only one side of the engine well, but grinding revealed that the delamination was just as deep on both sides.

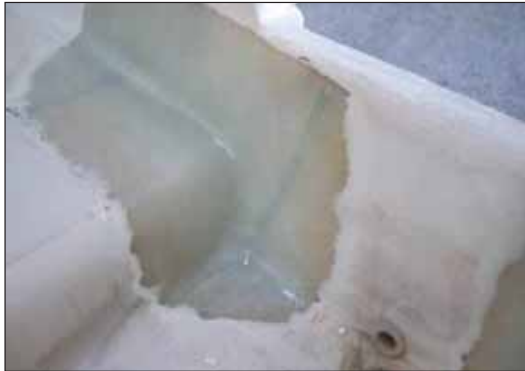
**Figure 150**

In this example, the resin chosen for use was epoxy, but vinylester might also have performed well.

It should be borne in mind that this was a single-sided repair and the original polyester laminate was already showing weakness from fatigue.

The reinforcement was a mix of 290-g woven twill and 450-g double-bias fibreglass, chosen because of drape ability and good performance with epoxy.

It is important to take all these matters into consideration when designing the repair laminate (see Figure 150). If additional reinforcement is required to maintain the boat's overall strength, care should be taken to avoid excessive laminate buildup, since this can increase the risk of developing stress concentrations.

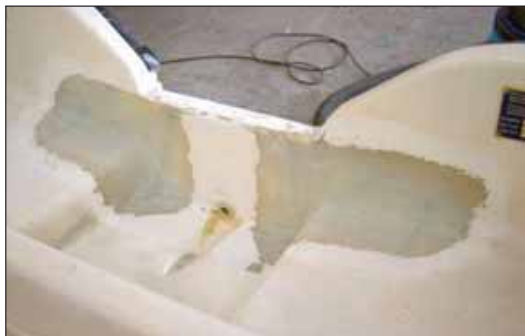
**Figure 151**

At this stage, the laminate buildup has been completed and the surface has been ground flat to a nice “finish”. Use of any form of putty on structural repairs is to be carefully avoided.

Putty has a low ratio of elongation to break, and will break up and crack much more quickly than a laminate.

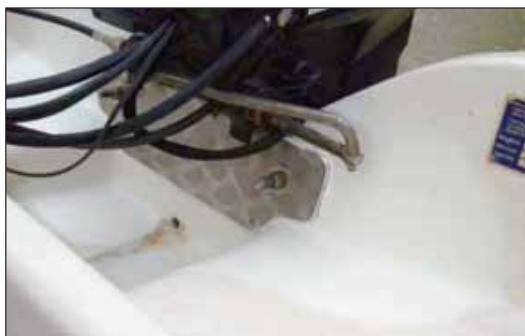
**Figure 152**

This figure shows the finished product. Gelcoat has been applied, water-sanded, buffed and polished to a decent gloss.

Polyester gelcoat can be used on top of epoxy as long as the epoxy is cured properly and the epoxy surface has been fully sanded before the gelcoat is applied.

In this case, a 5-mm aluminium plate has also been attached to distribute pressure from the bolts over a larger area.
