EXPERIMENTAL SHRIMP FARMING IN PONDS IN
POLEKURRU, ANDHRA PRADESH, INDIA

BOBP/WP/46

J.A.J. Janssen
*Aquaculturist (Associate Professional Officer),
Bay of Bengal Programme*

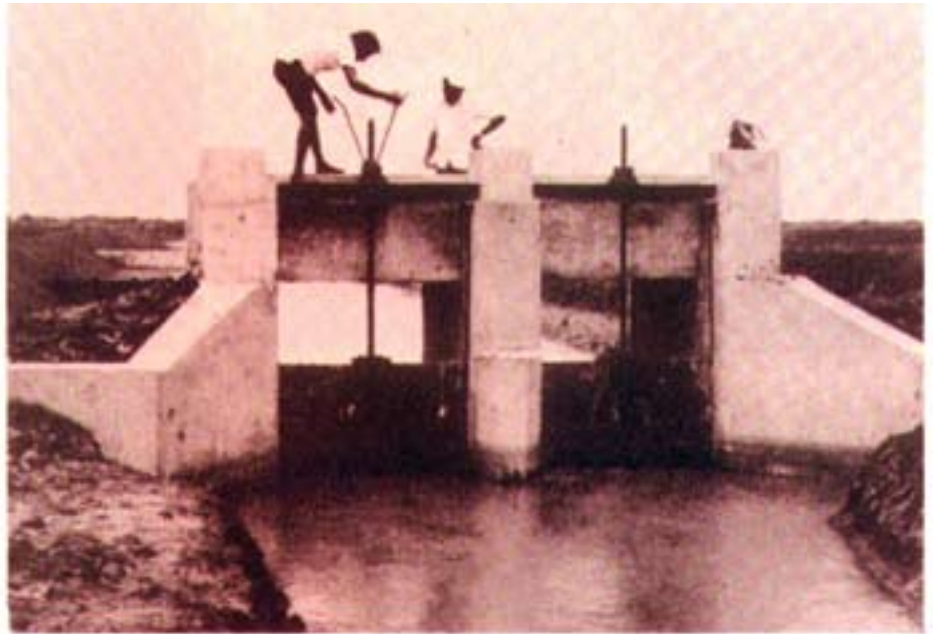
iwo-vent main sluice

The *main sluice gate* is constructed on a concrete and sand foundation. It has two vents, each 1.5 m wide, and is open up to the deck slab which is at + 3.00 m. The deck slab made of M 150 (1 part cement: 2 parts sand: 4 parts small stones) has been provided for passage across the gate. The sluice gate shutters are 1.5 m wide and 1.80 m high and are of the screw rod type which are operated in guiding channels fixed in the abutment and the pier. The screw rod (5 cm thick) is operated by a U type rotating bow from the deck slab. Each shutter is made of seasoned teak wood planks (5 cm thick) contained in a flat iron frame (6 mm thick). The bottom and the two vertical sides of each shutter are fitted with rubber linings (Appendix 5).

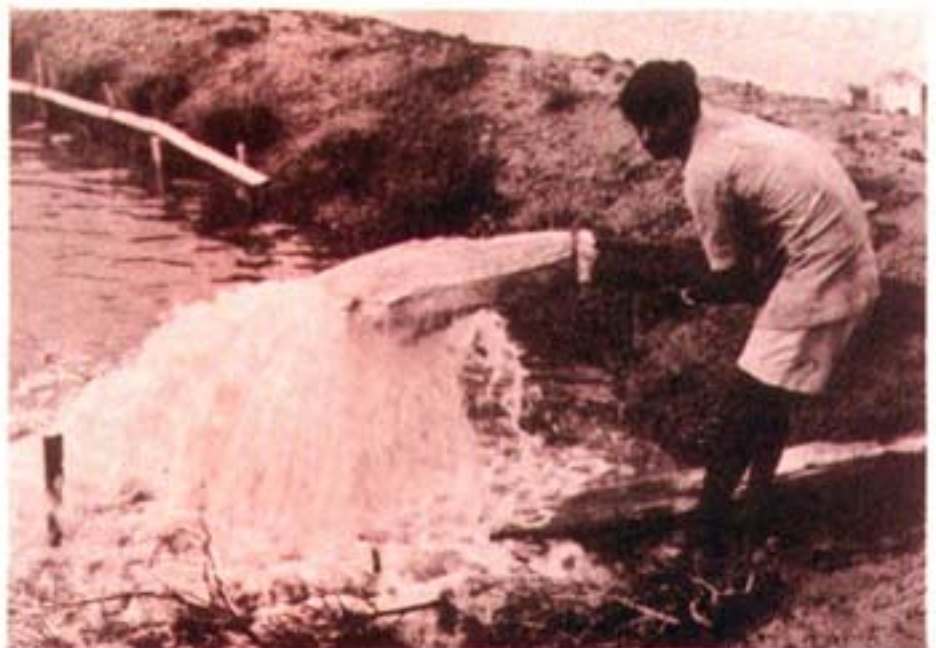
Aeration in pond 6 by pumped water

9. Pumping additionally aerates the pond, and can be used to tide over oxygen crisis but there is a need to design low-cost aerators.
10. A simple hand net was found most effective for seed collection. Shrimp seed was available throughout the year but species composition and quantity varied. Stocking large juveniles (30-45 mm) increases survival and reduces grow-out time. Therefore nursery management is seen as an important aspect of culture.

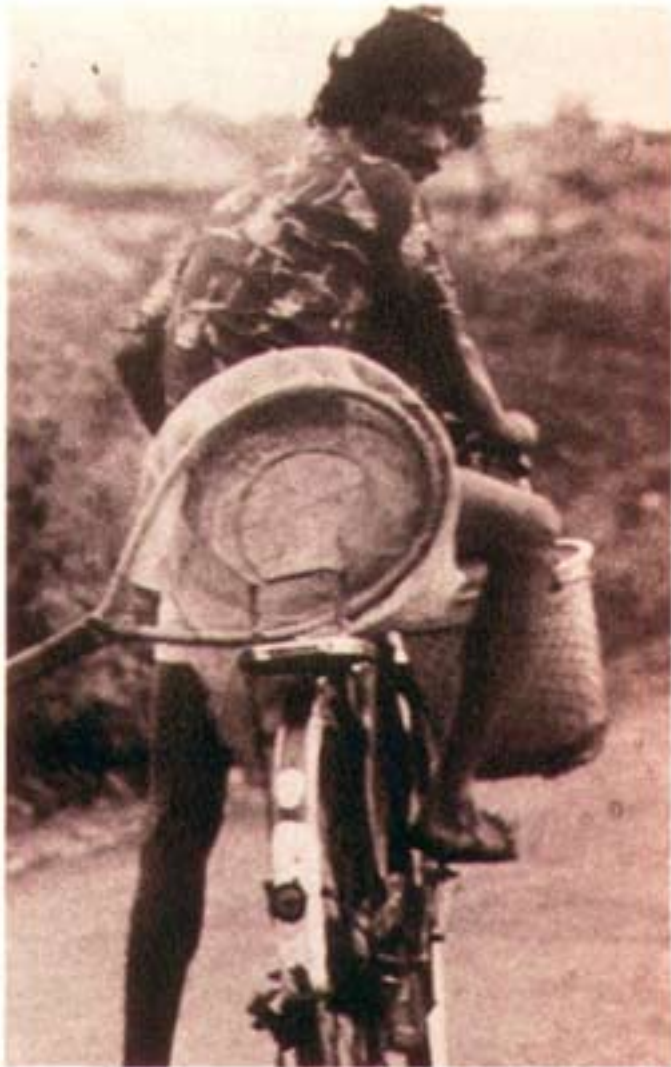
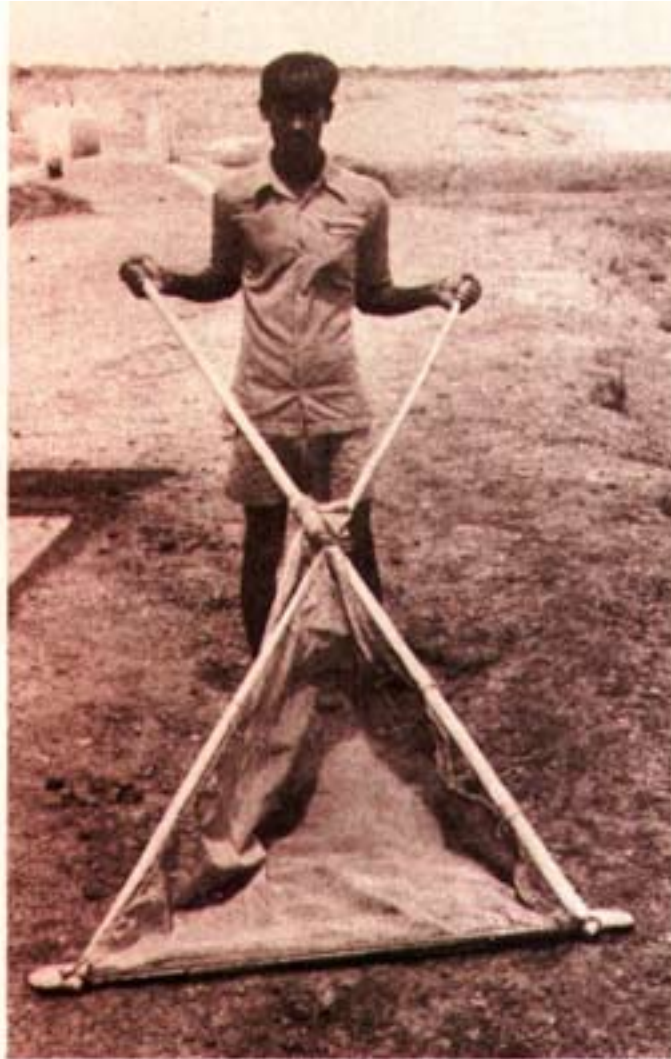
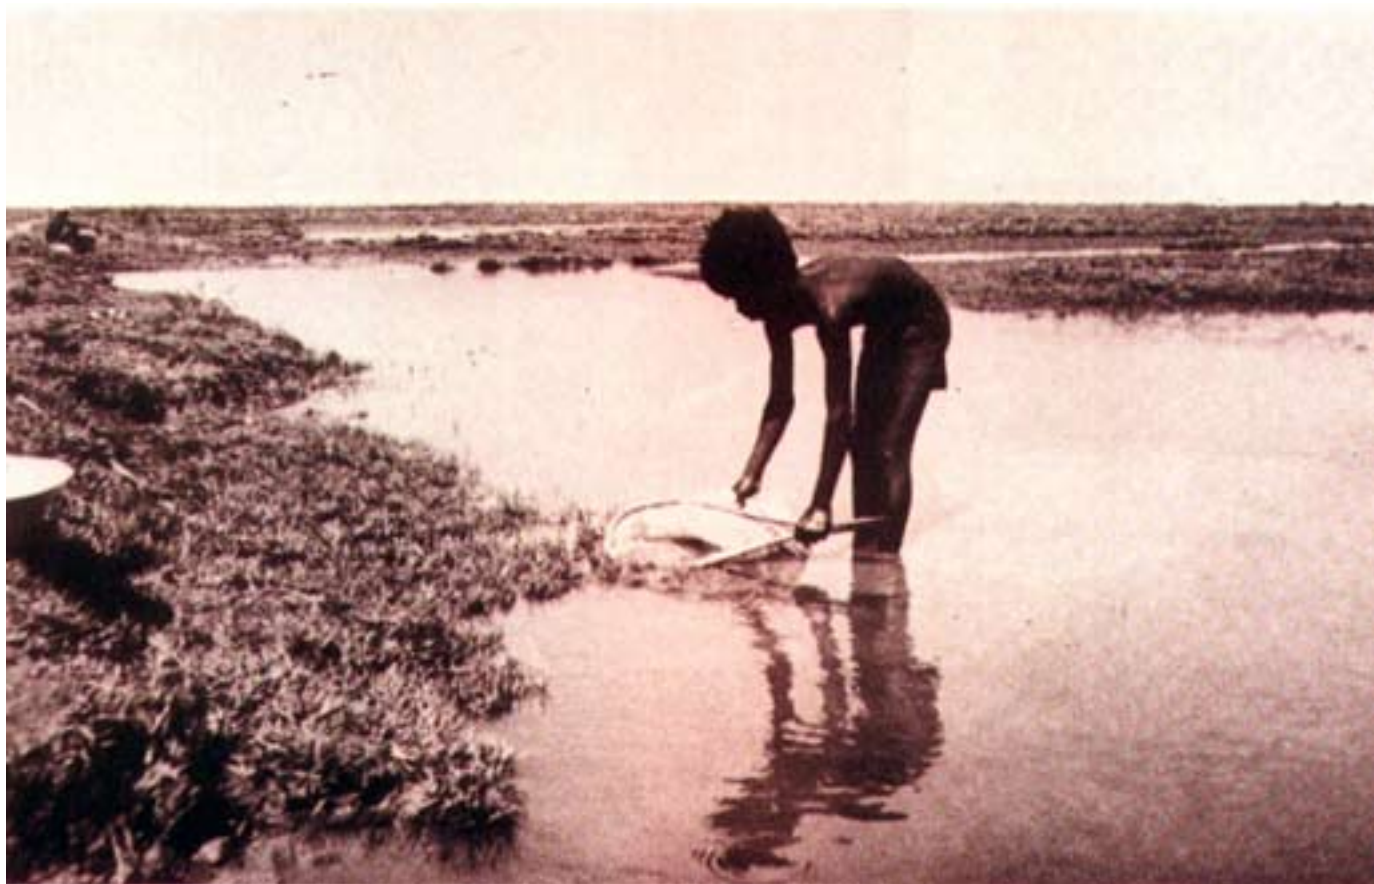
*Left above: Shrimp seed collector with bucket, handnet and bike
Right: Pushnet with wooden frame Below: Catching tiger shrimp juveniles*

results for *P. indicus* and *P. monodon*. The hand net (net opening 0.14 m) appears to be the most suitable gear for collection of *P. monodon* seed. They are caught in high densities in the submerged vegetation near the edge of the creeks where the other gear cannot be used effectively. *P. indicus* is caught with all tested gears at a rate of 100-200 per half hour all the year round. *P. monodon* catches varied from a few to 2400 caught by hand net in a half hour operation by one man (see Appendix 10). Metapenaeid species were caught in large numbers (200-2600) with push and drag nets.
